# DRYZONE®

The world's most rigorously tested rising damp treatment

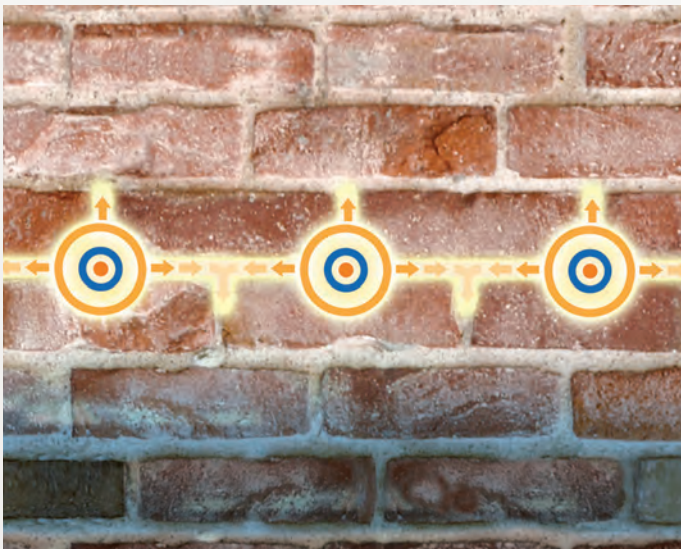
The introduction of the patented Dryzone damp-proofing cream has revolutionised the treatment of Rising Damp. The Dryzone cream is introduced by means of a simple applicator gun into a series of holes drilled into the mortar course. Once the Dryzone is installed, it diffuses to where it is most needed before curing to form a water-repellent resin.
